INSPECTION

2002 ECHO (RM884U)

BODY - SEAT BELT PRETENSIONER

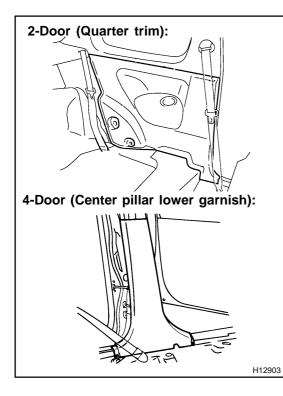
- (b) Perform a visual check which includes the following items with the front seat outer belt removed from the vehicle.
 - Check for cuts and cracks in, or marked discoloration on the quarter trim or center pillar lower garnish.
 - Check for cuts and cracks in wire harness, and for chipping in connectors.

Check for deformation of the quarter panel or center pillar.

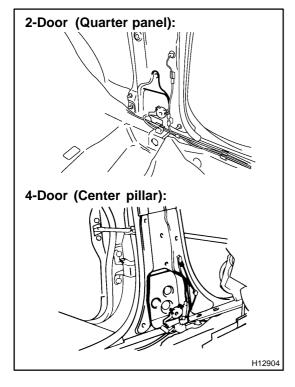
• Check for cuts and minute cracks in wire harness or marked discoloration on the front seat outer belt.
