DI1BH-21

DTC	B0132/61	Short in P/T Squib (RH) Circuit (to Ground)	
-----	----------	---	--

2002 ECHO (RM884U)

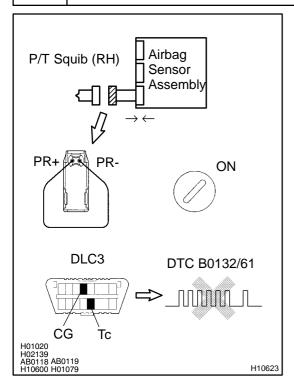
3

Check airbag sensor assembly.

- (a) Connect the connector to the airbag sensor assembly.
- (b) Using a service wire, connect PR+ and PR- of the connector (on the seat belt pretensioner side) between the seat belt pretensioner (RH) and the airbag sensor assembly.
- (c) Connect negative (-) terminal cable to the battery, and wait at least for 2 seconds.

- (a) Turn the ignition switch to ON and wait at least for 20 seconds.
- (b) Clear DTC stored in memory (See step 5 on page DI-239).
- (c) Turn the ignition switch to LOCK, and wait at least for 20 seconds.
- (d) Turn the ignition switch to ON, and wait at least for 20 seconds
- (e) Check DTC (See page DI-239).

DTC B0132/61 is not output.

Replace airbag sensor assembly.

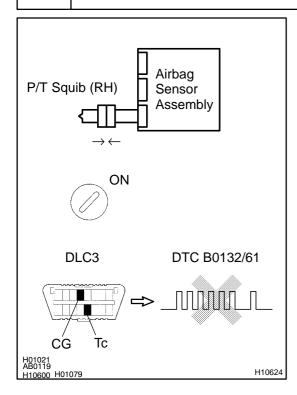
4 Check P/T squib (RH).

- (a) Turn the ignition switch to LOCK.
- (b) Disconnect negative (-) terminal cable from the battery, and wait at least for 90 seconds.
- (c) Connect the seat belt pretensioner (RH) connector.
- (d) Connect negative (-) terminal cable to the battery, and wait at least for 2 seconds.

- (a) Turn the ignition switch to ON, and wait at least for 20 seconds
- (b) Clear DTC stored in memory (See step 5 on page DI-239).
- (c) Turn the ignition switch to LOCK, and wait at least for 20 seconds.
- (d) Turn the ignition switch to ON, and wait at least for 20 seconds.
- (e) Check DTC (See page DI-239).

DTC B0132/61 is not output.

NG Replace seat belt pretensioner (RH).
