DTC B0133/62 Short in P/T Squib (RH) Circuit (to B+)
--

2002 ECHO (RM884U)

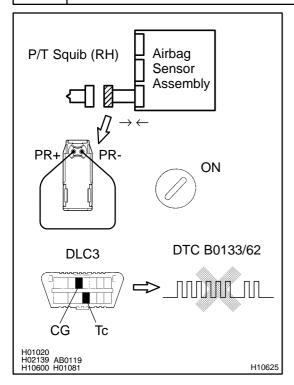
Check airbag sensor assembly.

PREPARATION:

- (a) Connect the connector to the airbag sensor assembly.
- (b) Using a service wire, connect PR+ and PR- of the connector (on the seat belt pretensioner side) between the seat belt pretensioner (RH) and the airbag sensor assembly.
- (c) Connect negative (-) terminal cable to the battery, and wait at least for 2 seconds.

CHECK:

- (a) Turn the ignition switch to ON and wait at least for 20 seconds.
- (b) Clear DTC stored in memory (See step 5 on page DI-239).
- (c) Turn the ignition switch to LOCK, and wait at least for 20 seconds.
- (d) Turn the ignition switch to ON, and wait at least for 20 seconds
- (e) Check DTC (See page DI-239).

DTC B0133/62 is not output.

Replace airbag sensor assembly.

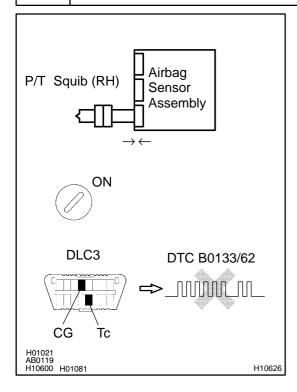
4 Check P/T squib (RH).

PREPARATION:

- (a) Turn the ignition switch to LOCK.
- (b) Disconnect negative (-) terminal cable from the battery, and wait at least for 90 seconds.
- (c) Connect the seat belt pretensioner (RH) connector.
- (d) Connect negative (-) terminal cable to the battery, and wait at least for 2 seconds.

CHECK:

- (a) Turn the ignition switch to ON, and wait at least for 20 seconds
- (b) Clear DTC stored in memory (See step 5 on page DI-239).
- (c) Turn the ignition switch to LOCK, and wait at least for 20 seconds.
- (d) Turn the ignition switch to ON, and wait at least for 20 seconds.
- (e) Check DTC (See page DI-239).

DTC B0133/62 is not output.

Replace seat belt pretensioner (RH).
