DTC	B0135/73	Short in P/T Squib (LH) Circuit	DITOW⊶o

2002 ECHO (RM884U)

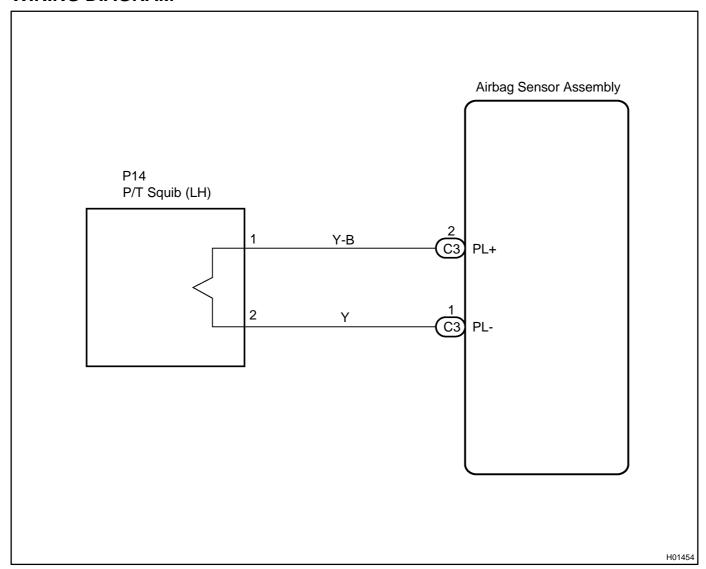
WIRING DIAGRAM

The P/T squib (LH) circuit consists of the airbag sensor assembly and seat belt pretensioner (LH). It causes the SRS to deploy when the SRS deployment conditions are satisfied. For details of the function of each component, see OPERATION on page RS-2. DTC B0135/73 is recorded when a short is detected in the P/T squib (LH) circuit.

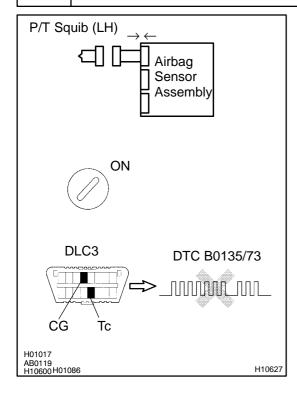
Check airbag sensor assembly.

PREPARATION:

- (a) Connect the connector to the airbag sensor assembly.
- (b) Connect negative (-) terminal cable to the battery, and wait at least for 2 seconds.

CHECK:

- (a) Turn the ignition switch to ON and wait at least for 20 seconds.
- (b) Clear DTC stored in memory. (See page DI-239)
- (c) Turn the ignition switch to LOCK, and wait at least for 20 seconds.
- (d) Turn the ignition switch to ON, and wait at least for 20 seconds.
- (e) Check DTC. (See page DI-239)

DTC B0135/73 is not output.

Replace airbag sensor assembly.

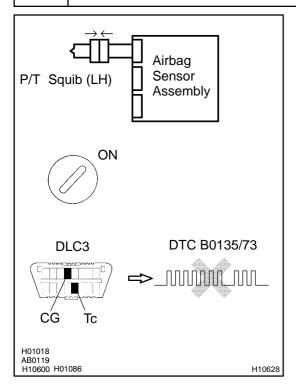
4 Check P/T squib (LH).

PREPARATION:

- (a) Turn the ignition switch to LOCK.
- (b) Disconnect negative (-) terminal cable from the battery, and wait at least for 90 seconds.
- (c) Connect the seat belt pretensioner (LH) connector.
- (d) Connect negative (-) terminal cable to the battery, and wait at least for 2 seconds.

CHECK:

- (a) Turn the ignition switch to LOOK, and wait at least for 20 second.
- (b) Turn the ignition switch to ON, and wait at least for 20 seconds.
- (c) Clear DTC stored in memory. (See page DI-239)
- (d) Turn ignition switch to LOCK, and wait at least for 20 seconds.
- (e) Turn the ignition switch to ON, and wait at least for 20 seconds.
- (f) Check DTC. (See page DI-239)

DTC B0135/73 is not output.

Replace seat belt pretensioner (LH).
