DTC B0138/72 Short in P/T Squib (LH) Circuit (to B+)

2002 ECHO (RM884U)

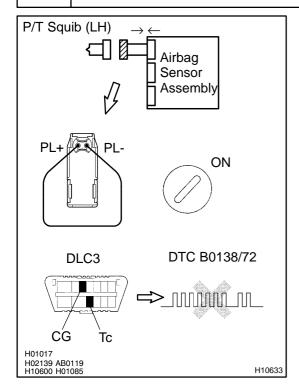
3

Check airbag sensor assembly.

- (a) Connect the connector to the airbag sensor assembly.
- (b) Using a service wire, connect PL+ and PL- of the connector (on the seat belt pretensioner side) between the seat belt pretensioner (LH) and the airbag sensor assembly.
- (c) Connect negative (-) terminal cable to the battery, and wait at least for 2 seconds.

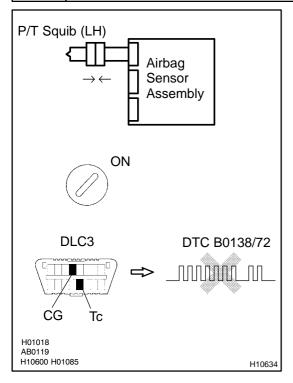
4 Check P/T squib (LH).

- (a) Turn the ignition switch to LOCK.
- (b) Disconnect negative (-) terminal cable from the battery, and wait at least for 90 seconds.
- (c) Connect the seat belt pretensioner (LH) connector.
- (d) Connect negative (-) terminal cable to the battery, and wait at least for 2 seconds.
