DTC	P0171	System too Lean (Fuel Trim)
------------	--------------	------------------------------------

CIRCUIT DESCRIPTION

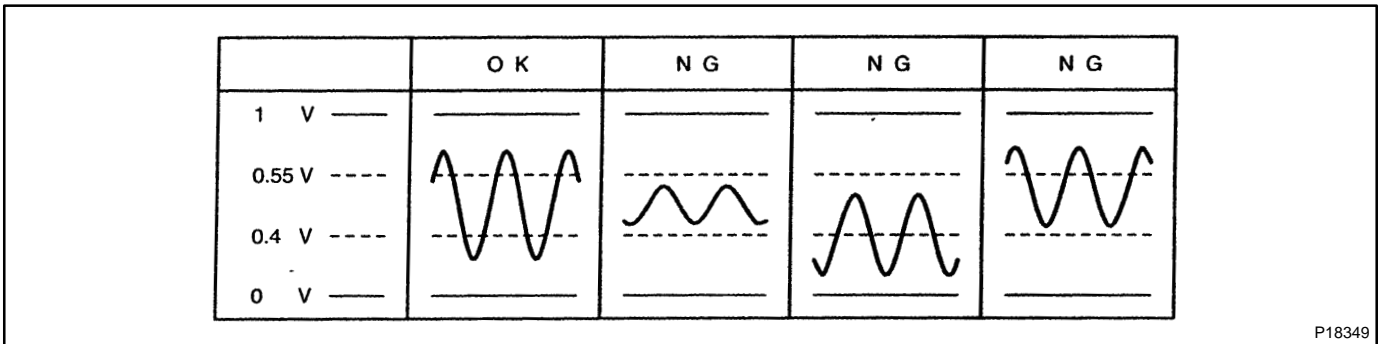
Oxygen sensor output voltage:

Alternates repeatedly between less than 0.4 V and more than 0.55 V (See the following table).
