DTC	P0335	Crankshaft Position Sensor "A" Circuit Malfunction	
-----	-------	--	--

2002 ECHO (RM884U)

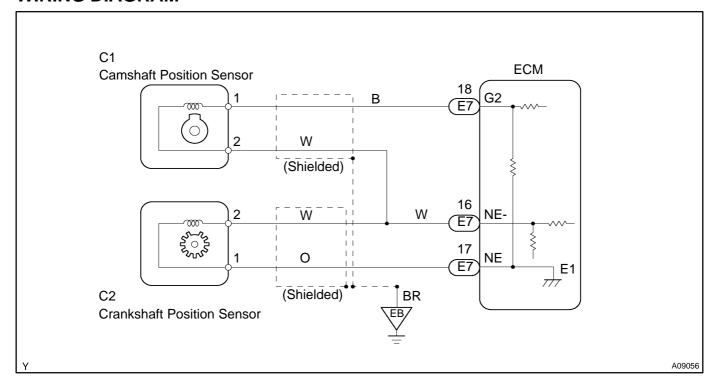
WIRING DIAGRAM

Crankshaft position sensor (NE signal) consist of a signal plate and pick up coil.

The NE signal plate has 34 teeth and is mounted on the crankshaft. The NE signal sensor generates 34 signals of every engine revolution. The ECM detects the standard crankshaft angle based on the G2 signals, and the actual crankshaft angle the engine speed by the NE signals.
