DI4L2-12

DTC B0102/11 Short in D Squib Circuit (to Ground)

2002 ECHO (RM884U)

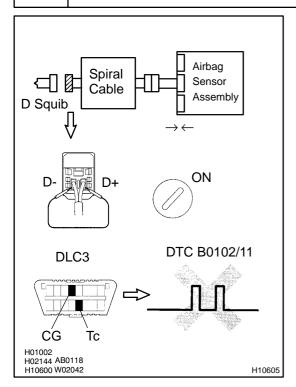
3

Check airbag sensor assembly.

PREPARATION:

- (a) Connect the connector to the airbag sensor assembly.
- (b) Using a service wire, connect D+ and D- of the connector (on the spiral cable side) between the spiral cable and the steering wheel pad.
- (c) Connect negative (-) terminal cable to the battery, and wait at least for 2 seconds.

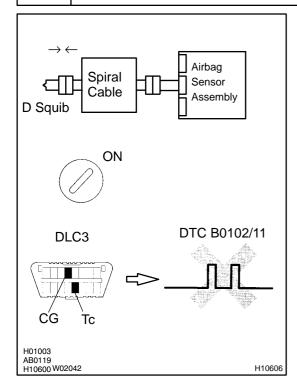
4 Check D squib.

PREPARATION:

- (a) Turn the ignition switch to LOCK.
- (b) Disconnect negative (-) terminal cable from the battery, and wait at least for 90 seconds.
- (c) Connect the steering wheel pad connector.
- (d) Connect negative (-) terminal cable to the battery, and wait at least for 2 seconds.
