DI1B8-20

DTC	B0107/51	Short in P Squib Circuit (to Ground)
-----	----------	--------------------------------------

2002 ECHO (RM884U)

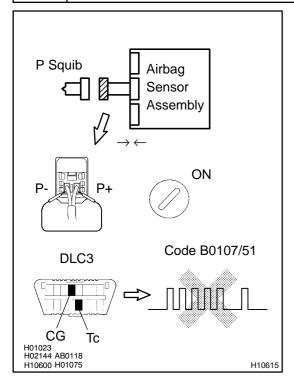
3 Check airbag sensor assembly.

PREPARATION:

- (a) Connect the connector to the airbag sensor assembly.
- (b) Using a service wire, connect P+ and P- of the connector (on the front passenger airbag assembly side) between the front passenger airbag assembly and the airbag sensor assembly.
- (c) Connect negative (-) terminal cable to the battery, and wait at least for 2 seconds.

CHECK:

- (a) Turn the ignition switch to ON and wait at least for 20 seconds.
- (b) Clear DTC stored in memory (See step 5 on page DI-239).
- (c) Turn the ignition switch to LOCK, and wait at least for 20 seconds.
- (d) Turn the ignition switch to ON, and wait at least for 20 seconds
- (e) Check DTC (See page DI-239).

OK:

DTC B0107/51 is not output.

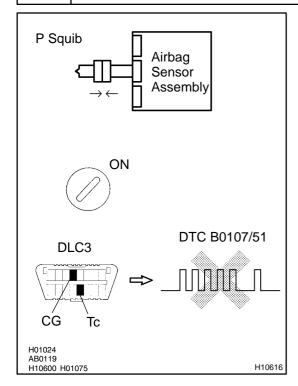
4 Check P squib.

PREPARATION:

- (a) Turn the ignition switch to LOCK.
- (b) Disconnect negative (-) terminal cable from the battery, and wait at least for 90 seconds.
- (c) Connect the front passenger airbag assembly connector.
- (d) Connect negative (-) terminal cable to the battery, and wait at least for 2 seconds.

CHECK:

- (a) Turn the ignition switch to ON, and wait at least for 20 seconds.
- (b) Clear DTC stored in memory (See step 5 on page DI-239).
- (c) Turn the ignition switch to LOCK, and wait at least for 20 seconds.
- (d) Turn the ignition switch to ON, and wait at least for 20 seconds.
- (e) Check DTC (See page DI-239).

OK:

DTC B0107/51 is not output.
