DTC B0115/47 Short in Side Squib (LH) Circuit	BING-18
---	---------

2002 ECHO (RM884U)

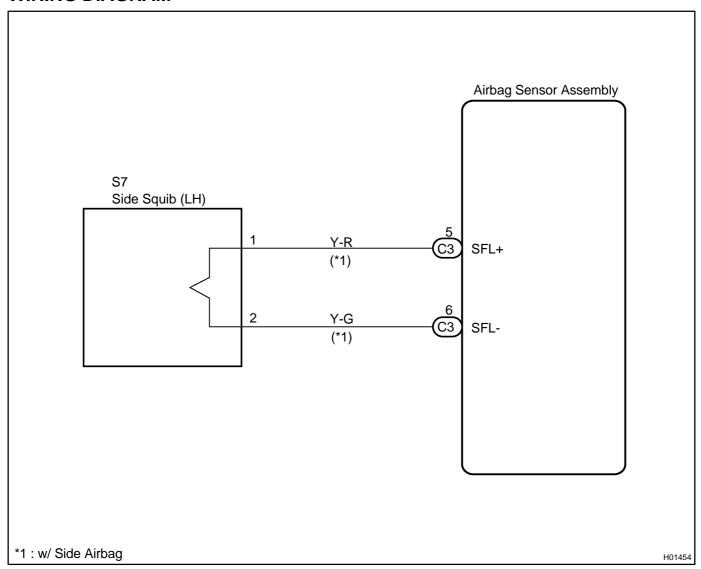
WIRING DIAGRAM

The side squib (LH) circuit consists of the airbag sensor assembly and side airbag assembly (LH). It causes the SRS to deploy when the SRS deployment conditions are satisfied. For details of the function of each component, see OPERATION on page RS-2. DTC B0115/47 is recorded when a short is detected in the side squib (LH) circuit.

DTC No.	DTC Detecting Condition	Trouble Area
B0115/47	 Short circuit between SFL+ wire harness and SFL- wire harness of squib Side squib (LH) malfunction Airbag sensor assembly malfunction 	Side airbag assembly (LH) Airbag sensor assembly Wire harness

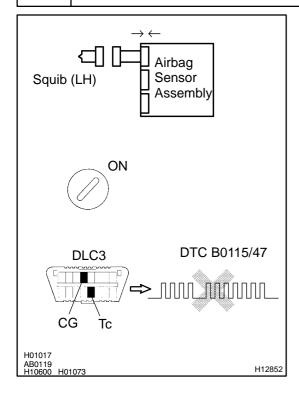
Check airbag sensor assembly.

PREPARATION:

- (a) Connect the connector to the airbag sensor assembly.
- (b) Connect the negative (-) terminal cable to the battery, and wait at least for 2 seconds.

CHECK:

- (a) Turn the ignition switch to ON and wait at least for 20 seconds.
- (b) Clear the DTC stored in memory (See page DI-239).
- (c) Turn the ignition switch to LOCK, and wait at least for 20 seconds.
- (d) Turn the ignition switch to ON and wait at least for 20 seconds.
- (e) Check the DTC (See page DI-239).

DTC B0115/47 is not output.

Replace airbag sensor assembly.

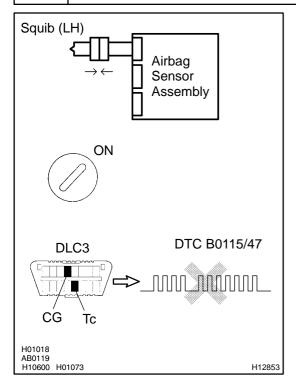
4 Check side squib (LH).

PREPARATION:

- (a) Turn the ignition switch to LOCK.
- (b) Disconnect the negative (-) terminal cable from the battery, and wait at least for 90 seconds.
- (c) Connect the side airbag assembly (LH) connector.
- (d) Connect the negative (-) terminal cable to the battery, and wait at least for 2 seconds.

CHECK:

- (a) Turn the ignition switch to LOOK, and wait at least for 20 second.
- (b) Turn the ignition switch to ON and wait at least for 20 seconds.
- (c) Clear the DTC stored in memory (See page DI-239).
- (d) Turn the ignition switch to LOCK, and wait at least for 20 seconds.
- (e) Turn the ignition switch to ON and wait at least for 20 seconds
- (f) Check the DTC (See page DI-239).

DTC B0115/47 is not output.

Replace side airbag assembly (LH).
