DI1N.I-14

DTC B0118/46 Short in Side Squib (LH) Circuit (to B+)

2002 ECHO (RM884U)

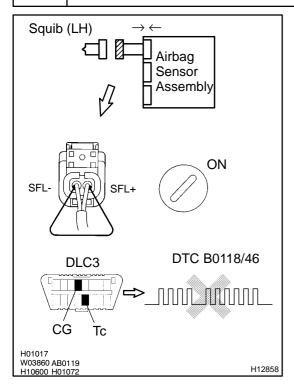
3

Check airbag sensor assembly.

- (a) Connect the connector to the airbag sensor assembly.
- (b) Using a service wire, connect SFL+ and SFL- of the connector (on the side airbag assembly side) between the side airbag assembly (LH) and the airbag sensor assembly.
- (c) Connect the negative (-) terminal cable to the battery, and wait at least for 2 seconds.

- (a) Turn the ignition switch to ON and wait at least for 20 seconds.
- (b) Clear the DTC stored in memory (See step 5 on page DI-239).
- (c) Turn the ignition switch to LOCK, and wait at least for 20 seconds.
- (d) Turn the ignition switch to ON and wait at least for 20 seconds.
- (e) Check the DTC (See page DI-239).

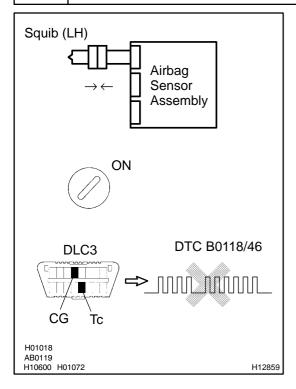
4 Check side squib (LH).

- (a) Turn the ignition switch to LOCK.
- (b) Disconnect the negative (-) terminal cable from the battery, and wait at least for 90 seconds.
- (c) Connect the side airbag assembly (LH) connector.
- (d) Connect the negative (-) terminal cable to the battery, and wait at least for 2 seconds.

- (a) Turn the ignition switch to ON and wait at least for 20 seconds
- (b) Clear the DTC stored in memory (See step 5 on page DI-239).
- (c) Turn the ignition switch to LOCK, and wait at least for 20 seconds.
- (d) Turn the ignition switch to ON and wait at least for 20 seconds
- (e) Check the DTC (See page DI-239).
